Title:	Troubleshooting Cameras with Water Ingress Issue	Version:	v1.0	Date:	06/28/2018
Product:	Outdoor Cameras			Page:	1 of 12
Action Required:	Information Only

Troubleshooting Cameras with Water Ingress Issue

Installers often encounter outdoor cameras fogged up or water flooded. This technical bulletin addresses the issues and provides solutions. If a camera needs to be returned, this bulletin also outlines the information needed to be collected in order for an engineer to identify the problem.

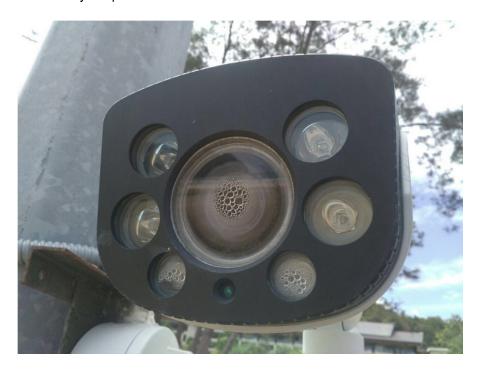
Figure 1, Camera Fogged Up

Humidity exists in the atmosphere, including inside a camera housing. When camera power is off, the temperature difference between inside and outside of a camera is not significant. Hence no condensation is formed.

When a camera is powered up, heat is generated by the components and warms up the moisture inside of the sealed housing. Due to the distance of the bubble dome away from the heat source, condensation is formed on the dome's interior surface. Some cameras have a thin waterproof film. The film equalizes the internal and external temperatures. When the dome is later warmed up, condensation will gradually disappear.

Hikvision cameras have two condensation-proof solutions.

- 1. Waterproofing film, used to equalize the internal and external temperature
- 2. Desiccant, to absorb the moisture inside the camera

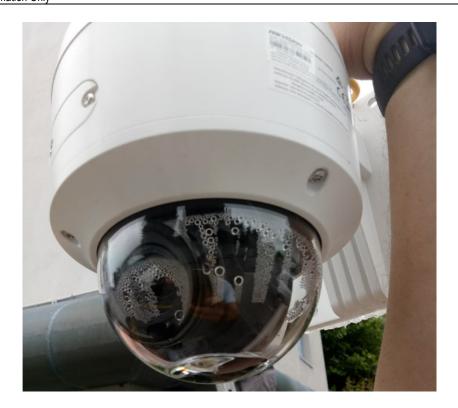
Figure 2, Water Ingress in Camera

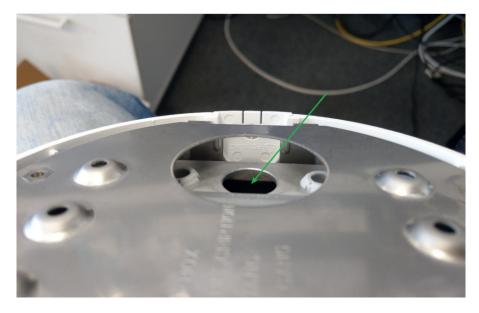
- 1. Seal is not installed or fitted properly.
- 2. For a camera with a built-in SD card slot, make sure the SD card slot cap is on and rubber seal is tight.

Figure 3, Water Seal Rubber Is Not Installed

- 3.3.1 Proper installation is standard operation procedure.
 - 1. Rubber seal needs to be pressed firmly. Seal must sit tightly onto the edge.

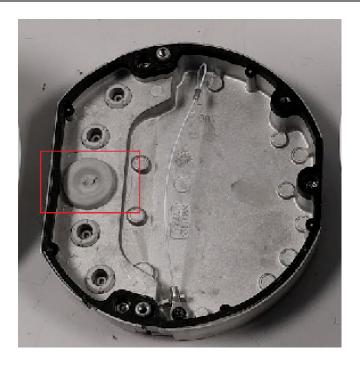
Figure 4, Rubber Seal Is Fitted Inside Out

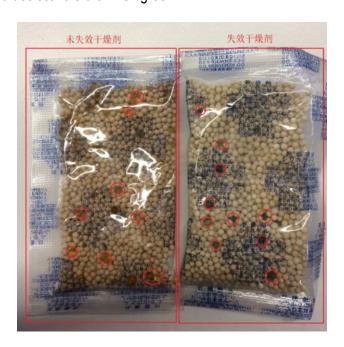
Hikvision camera desiccant comes with a color indicator. Good desiccant appears an orange color, whereas aged desiccant is brownish/green.

Figure 5, Left, Good Desiccant. Right, Bad Desiccant.

For water ingress due to failed desiccant, please RMA the camera to replace the desiccant. If it appears a batch desiccant issue, please contact the quality assurance department.

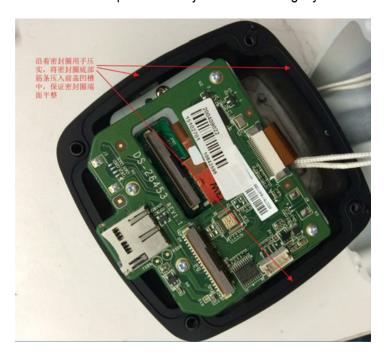
Figure 6, Rubber Seal Example

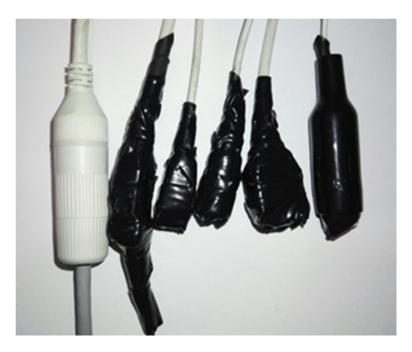
Figure 8, Waterproofing Pigtail Cable

- 3. The camera pigtail is not waterproof. Most Hikvision outdoor cameras are IP rated, but this does not include the cable entry pigtail. Pigtail waterproofing needs to be done during installation by the installer. Water will penetrate the Ethernet, BNC, or audio input port if not properly sealed.
- 4. Rubber seal is not installed or is not fitted properly. We see many installers not installing the seal or not fitting it properly, causing water to enter the housing.
- 5. Cable needs to enter the camera housing from below, creating a U-shape route to prevent water from dripping into the camera.

5. Use waterproof tape to wrap all connectors regardless of whether the connector is in use or not. The tape needs to cover at least 1½ inches above and below the connector.
